Manhole Inspection Summary

Manhole # S11Q__022MH

Inspection ☐ Is Incomplete Rating: **4) Poor**

Record Plat: **11Q** Node: **022** Status: **Other (Specify in comment)** Insp Date: **12/23/08 12:51 PM**

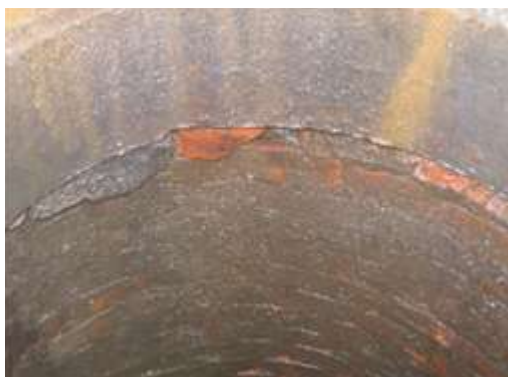
Defect 4

Condition: ☐ Sound ☐ Cracked ☐ Root Intrusion ☒ **Loose Brick** ☐ Deteriorated

Infiltration: ☐ None ☒ **Joint** ☐ Cracks ☐ Mortar ☐ Roots ☒ **Wall**

missing bricks and mortar at corbel with infiltration

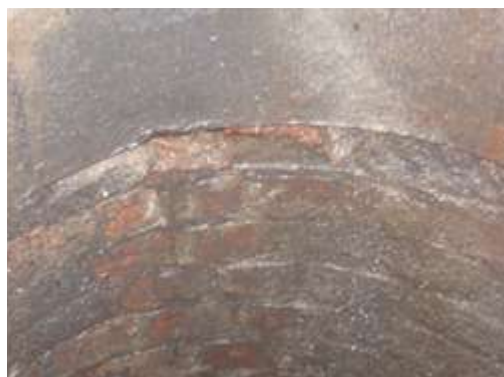
Defect 3

Condition: ☐ Sound ☐ Cracked ☒ **Leaks**

frame leaks

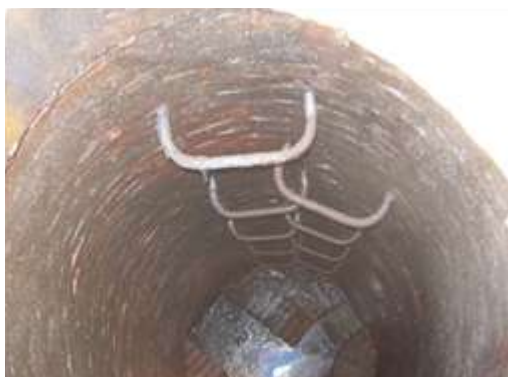
Defect 2

Count: **0** Missing: **0** ☒ **Corroded**

steps corroded

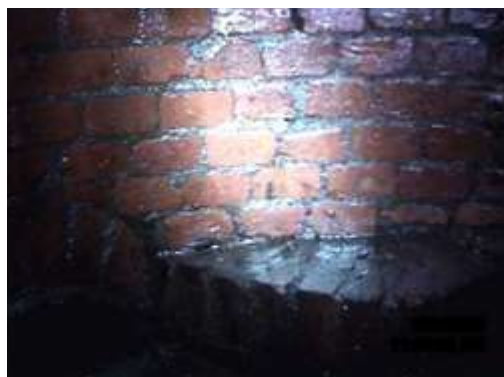
Defect 1

Infiltration: ☐ None ☐ Joint ☐ Cracks ☐ Mortar ☐ Roots ☒ **Wall**

barrel flow wall

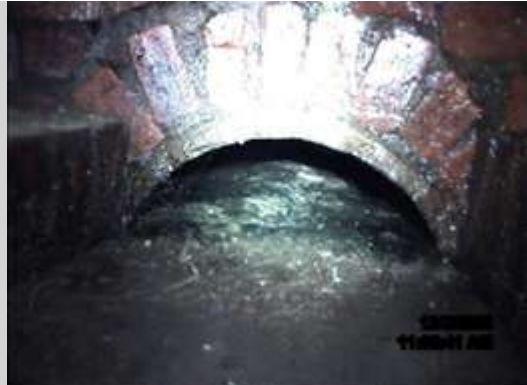
12 O'Clock Outflow

Pipe Height: **10.8** (in.) Rod and Bar (Angled)
Pipe Material: **Clay** ☐ Pipe Lined
Invert Depth: **15.82** (ft.) Flow Characteristics: **None**
Deposits: ☐ None ☐ Mud ☒ **Grout** ☐ Debris ☐ Grease
Silt Depth: **4** (in.) Deposits Extent: **Medium**
Infiltration: **None** Pipe Seal Cond: **Sound**

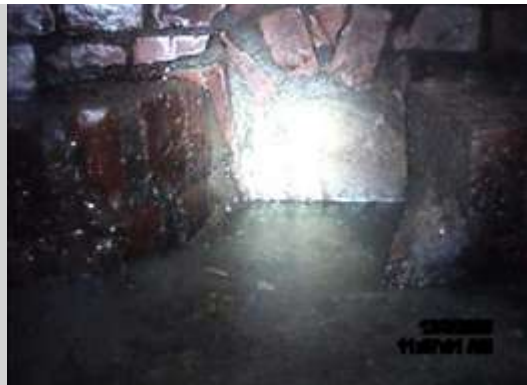
3 O'Clock Inflow

conc plugged opng

Pipe Height: **0** (in.)
Pipe Material: ☐ Pipe Lined
Invert Depth: **0.00** (ft.) Flow Characteristics:
Deposits: ☐ None ☐ Mud ☒ **Grout** ☐ Debris ☐ Grease
Silt Depth: **4** (in.) Deposits Extent: **Medium**
Infiltration: Pipe Seal Cond:

Connects To: **Stub connection / abandoned**

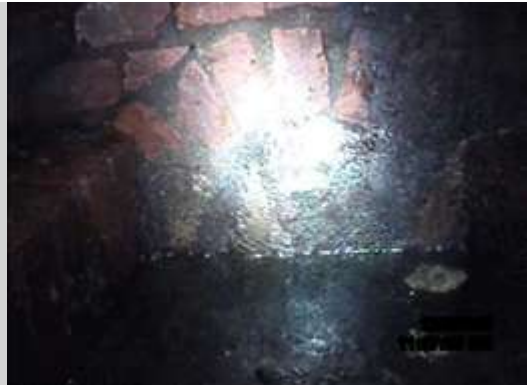
5 O'Clock Inflow

conc plugged opng

Deposits: ☐ None ☐ Mud ☒ Sludge ☐ Debris ☐ Grease

Silt Depth: 4 (in.) Deposits Extent: Medium

Connects To: Stub connection / abandoned

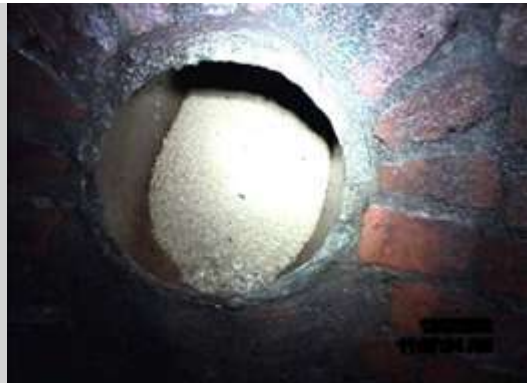
9 O'Clock Inflow

Deposits: ☐ None ☐ Mud ☒ Sludge ☐ Debris ☐ Grease

Silt Depth: 6 (in.) Deposits Extent: Heavy

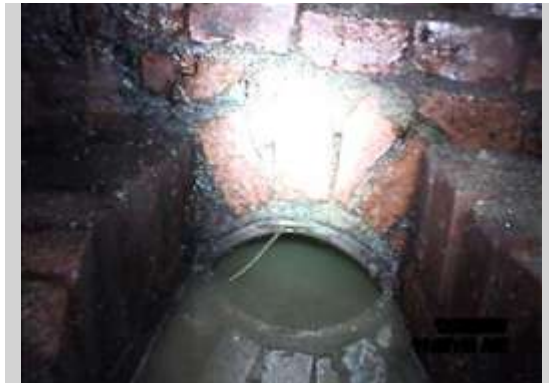
Drop In @ 9 O'Clock

Drop Condition: Partly Clogged
